TECH TALK

NAPA 100025

OE OX 813/1
BMW 11428575211

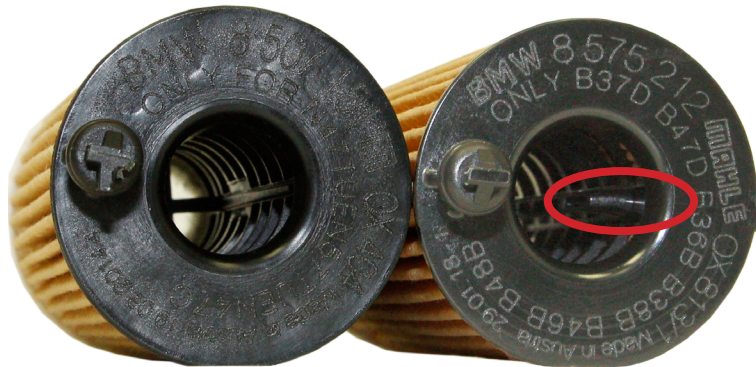
The NAPA 100025 is not a suitable replacement filter for applications requiring the OE filter OX 813/1 (BMW 11428575211). The OX 813/1 has an alignment tab inside of the filter center tube. The tab fits into a slot in the oil housing ensuring proper alignment during filter installation. The NAPA 100025 does not have the alignment tab and can be installed incorrectly resulting in low oil pressure during vehicle operation.

The correct NAPA replacement filter for the OE OX813/1 (BMW 11428575211) is the soon to be available NAPA 100358.
