Filters

Bloated Filters

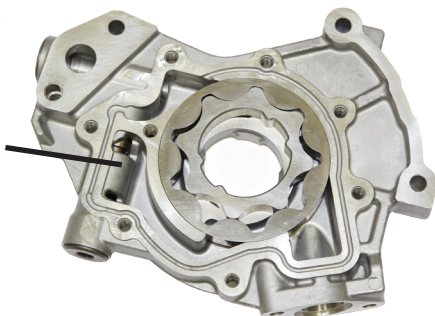
Under normal operating conditions, oil is forced by the oil pump throughout the engine for the purpose of both lubricating and cooling various internal engine components. Each vehicle has a predefined normal operating oil pressure which is set by the manufacturer and controlled by the use of a Pressure Relief Valve. The Pressure Relief Valve is most commonly located in the oil pump, where it opens and closes to regulate the flow of oil.

High flow from oil pump causes Pressure Relief Valve to open thereby regulating system pressure.

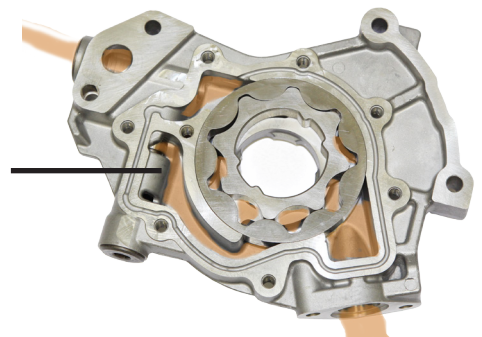
When the valve becomes stuck in the open position, the vehicle may experience low oil pressure as oil flow is allowed to immediately return to the oil sump.

Pressure Relief Valve is stuck in the open position allowing the oil to return to sump.

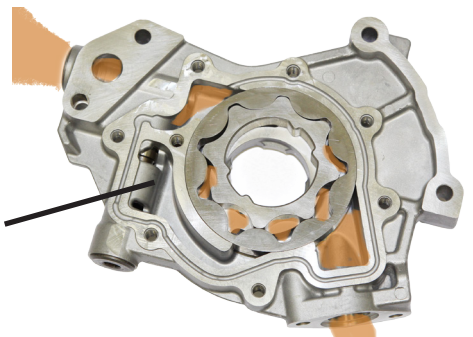
When the valve is stuck in the closed position, the lubrication system can be subjected to the maximum flow rate of the oil pump. This equates to an increase in oil pressure.

Since the oil filter is located after the pump, it is often first to be subjected to the uncontrolled surge in oil pressure. If this occurs, the filters will begin to deform or "bloat". If not corrected, the filter's baseplate may also bend allowing the gasket to become displaced. A displaced gasket will result in rapid oil loss which may result in engine failure.

Pressure Relief Valve is stuck in the closed position allowing the pump's complete oil volume to reach the filter.

A bloated filter is a warning indicator that the system's Pressure Relief Valve has at some point failed. Like many early stage mechanical failures, a sticking valve may be sporadic or even the result of temporary climatic conditions such as very cold morning. In either case, the sticky valve must be remedied to avoid damage to the filter and potentially the vehicle's engine.
